## **FIELD INSPECTION**

Project Name:	Mountain Valley Pipeline	Inspector:	Matthew Grant	
Inspection Date:	Thursday, February 14, 2019	Project Contact:	Brian Clauto	
Spread: Montgomery County MP 227 St#12035+19 & 12031+56 MP 228 St#12076+95	Spread H	Weather (Wet/Dry/Rain):	Dry	
STAGE OF CONSTRUCTI	ON: (Check all that apply)			
Clearing	Rough Grading	Trench Excavation	Pipe Assembly, Testing & Installation	
Backfilling and Grade	e Restoration	& Stabilization	Other: Dormant	
<ul> <li>erosion and sedime</li> <li>Are all control meas</li> <li>condition in accorda applicable, manufac</li> <li>Areas of offsite sedi</li> </ul>	d and implemented in accordance with the nt control plan and stormwater managementers properly maintained in effective oper unce with good engineering practices and, sturer specifications?  ment deposition were observed?	ent plans? rating		
no impacts were ob	ed streams included: S-G36, S-G40, oserved at the time of the inspection.  Corrective Action: N/A	S-G39, and S-MM15. ECD	were in place near all the streams,

Project Name: Mountain Valley Pipeline Date:Thursday, February 14, 2019

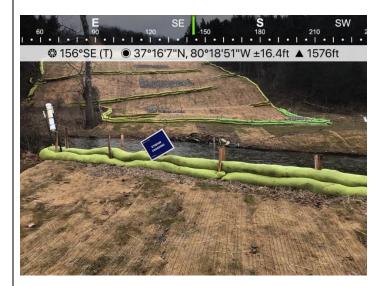
Fig. 1 Area near designated stream S-G36 has been temporarily stabilized and controls are in place.

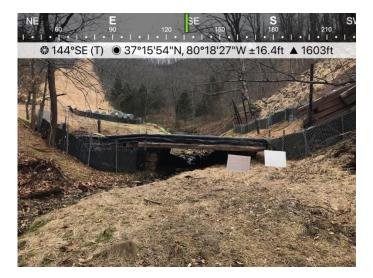
Fig. 2 Area near designated stream S-G40 has been temporarily stabilized and controls are in place.

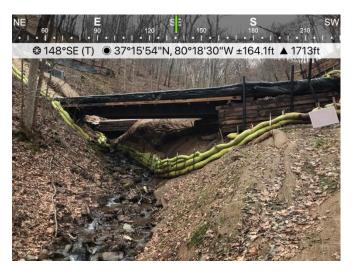
Fig. 3 Area near designated stream S-G39 has been temporarily stabilized and controls are in place.
